9.0 STONE CROSS SITES

FIGURE 10.1 STONE CROSS: SITE LOCATIONS

October 2016 11124101_Landscape Figures_20-10-16.indd WEALDEN LOCAL PLAN: LANDSCAPE & ECOLOGICAL ASSESSMENT OF POTENTIAL SITES WEALDEN DISTRICT COUNCIL FIGURE 10.2c STONE CROSS: 083/3280 PHOTOGRAPHS

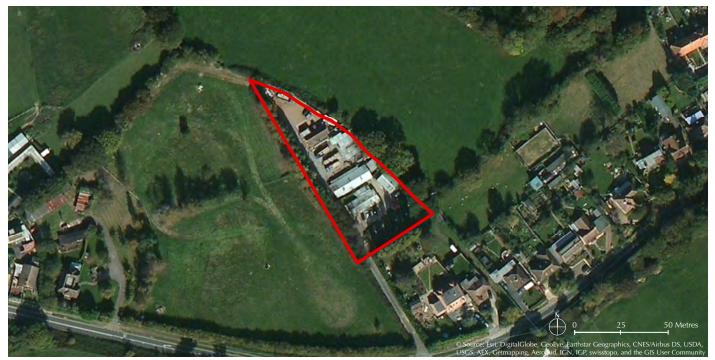
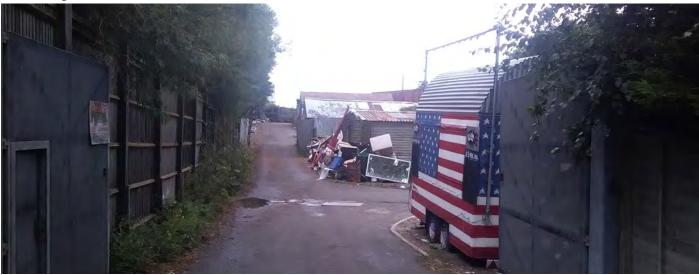
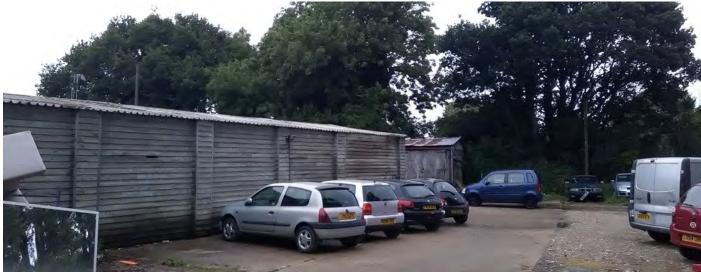
Typical views of the Site are illustrated by the photographs in **Figure 10.2c**.

The landscape features within the Site are mapped on **Figure 10.2b** and illustrated on **Figure 10.2c**. Located in open countryside to the east of Stone Cross, the Site is generally level. It comprises an irregular-shaped parcel of land, currently used as a scaffold yard. A number of permanent and temporary buildings exist on Site which has a light industrial character. Each of the Site boundaries include some trees, in particular a distinctive line of poplar along the south-eastern boundary.

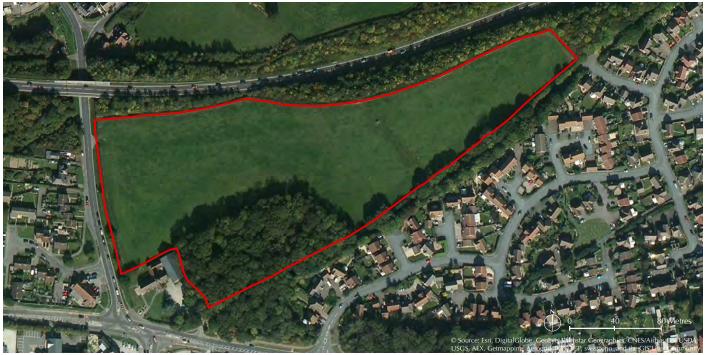
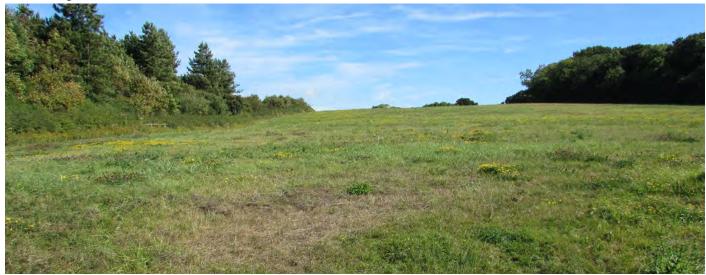
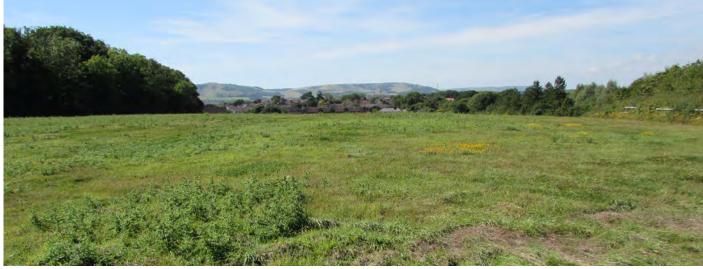
October 2016 11124101_Landscape Figures_20-10-16.indd WEALDEN LOCAL PLAN: LANDSCAPE & ECOLOGICAL ASSESSMENT OF POTENTIAL SITES WEALDEN DISTRICT COUNCIL FIGURE 10.5c STONE CROSS: 187/3280 PHOTOGRAPHS

Aerial Image of Site

Typical View into Site

Typical View out of Site

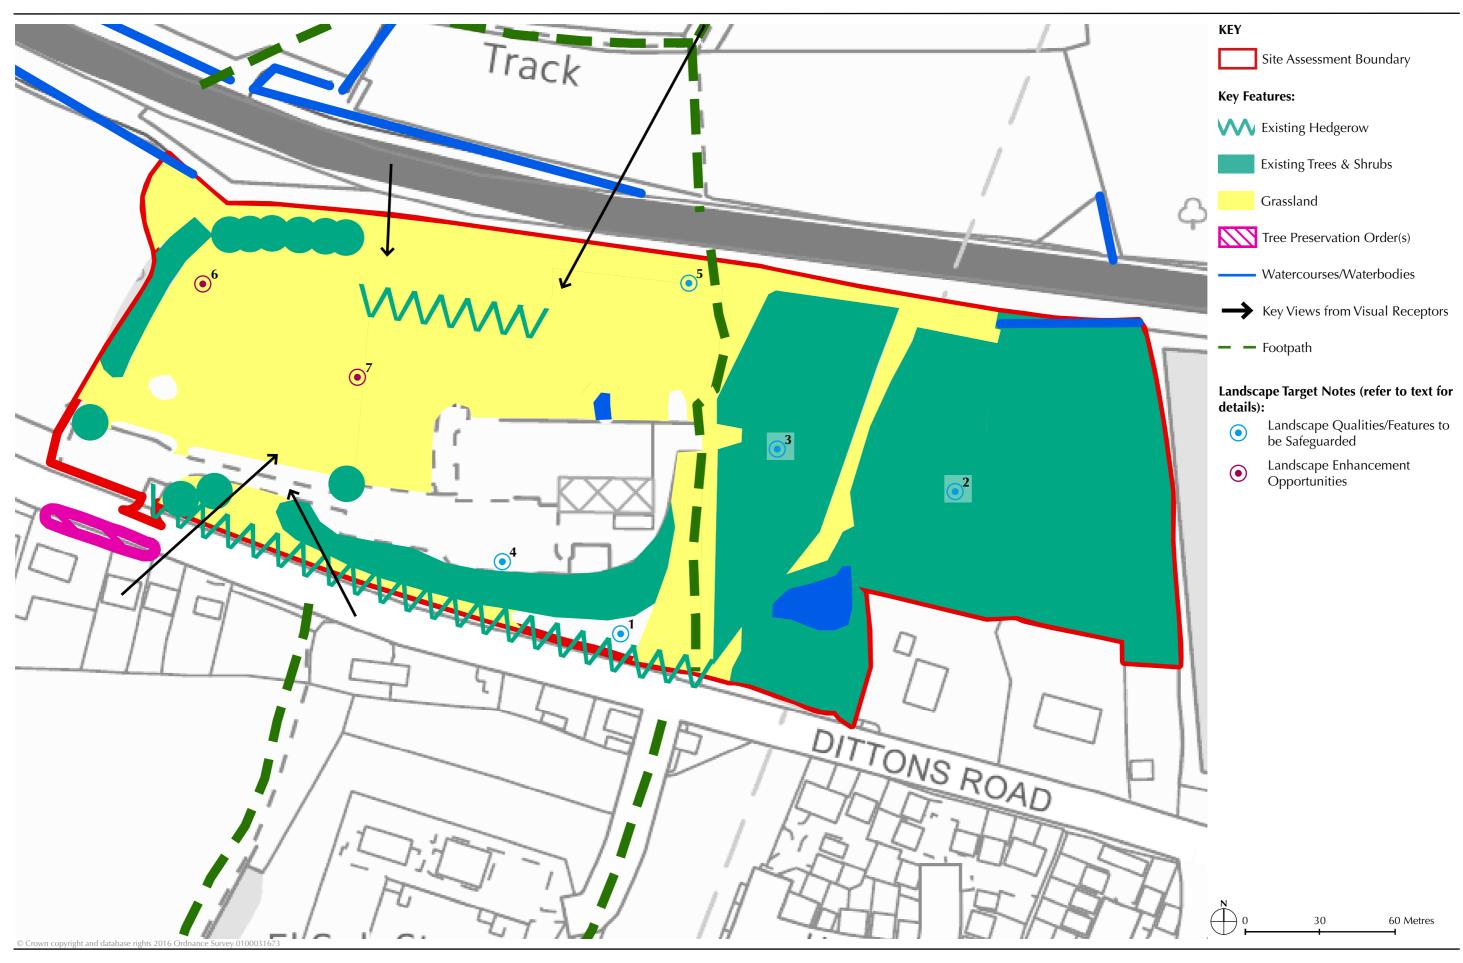
FIGURE 10.6a STONE CROSS: 529/3280 LANDSCAPE AND VISUAL CONTEXT

The landscape and visual context of the Site is shown on **Figure 10.6a**. The key characteristics/features which provide the context to this Site are:

Glimpsed views of the Site are possible from Dittons Road, and from surrounding property and rights of way. Views experienced from this Site to the north reach to a significant distance, extending across the Levels towards Glyndley Manor. Key views from visual receptors are shown on **Figure 10.6a.** These include:

Zone of Visual Influence: The approximate Zone of Visual Influence (ZVI) is shown on **Figure 10.6a**. The Site's ZVI is limited to the area of countryside to the north of the Site, however at this location the ZVI is extensive offering significant views north over the Levels. Views towards the Site are locally restricted east and west primarily by trees, and to the south of the Site the ZVI includes neighbouring residential properties only.

Key views into the Site are marked on **Figure 10.6a** and typical views are illustrated by the photographs in **Figure 10.6c**.

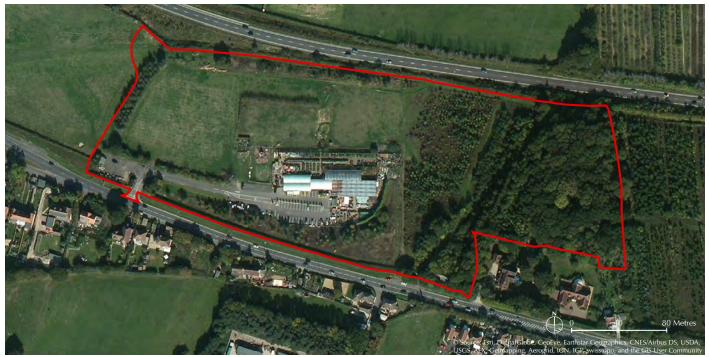
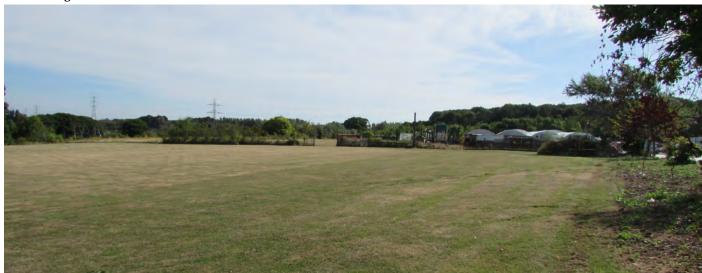
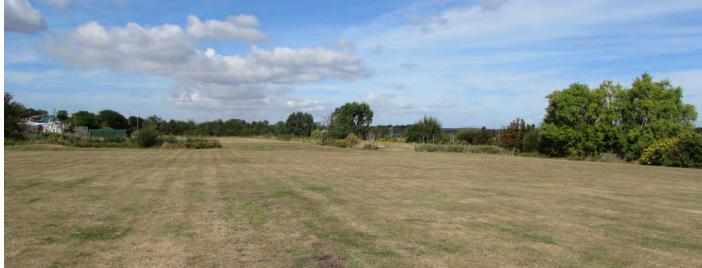
October 2016 11124101_Landscape Figures_20-10-16.indd WEALDEN LOCAL PLAN: LANDSCAPE & ECOLOGICAL ASSESSMENT OF POTENTIAL SITES WEALDEN DISTRICT COUNCIL FIGURE 10.6c STONE CROSS: 529/3280 PHOTOGRAPHS

Aerial Image of Site

Typical View into Site

Typical View out of Site

The landscape features within the Site are mapped on **Figure 10.6b** and illustrated on **Figure 10.6c**. Located on a ridge of high ground on the northern edge of Stone Cross, the Site is gently sloping to the north. Currently being used as a plant nursery and garden centre the Site comprises a single small area of amenity grassland, tree plantations, Ancient Woodland (The Dell) and buildings. Ponds also exist within the Site. Given these changes, much of the Site is not typical of the surrounding landscape but key characteristic landscape features such as the small blocks of Ancient Woodland remain. There is a limited sense of tranquillity on this site, resulting from road noise from the Pevensey Bypass (A27). The promoted long-distance 1066 Country Walk runs through the Site from north to south.

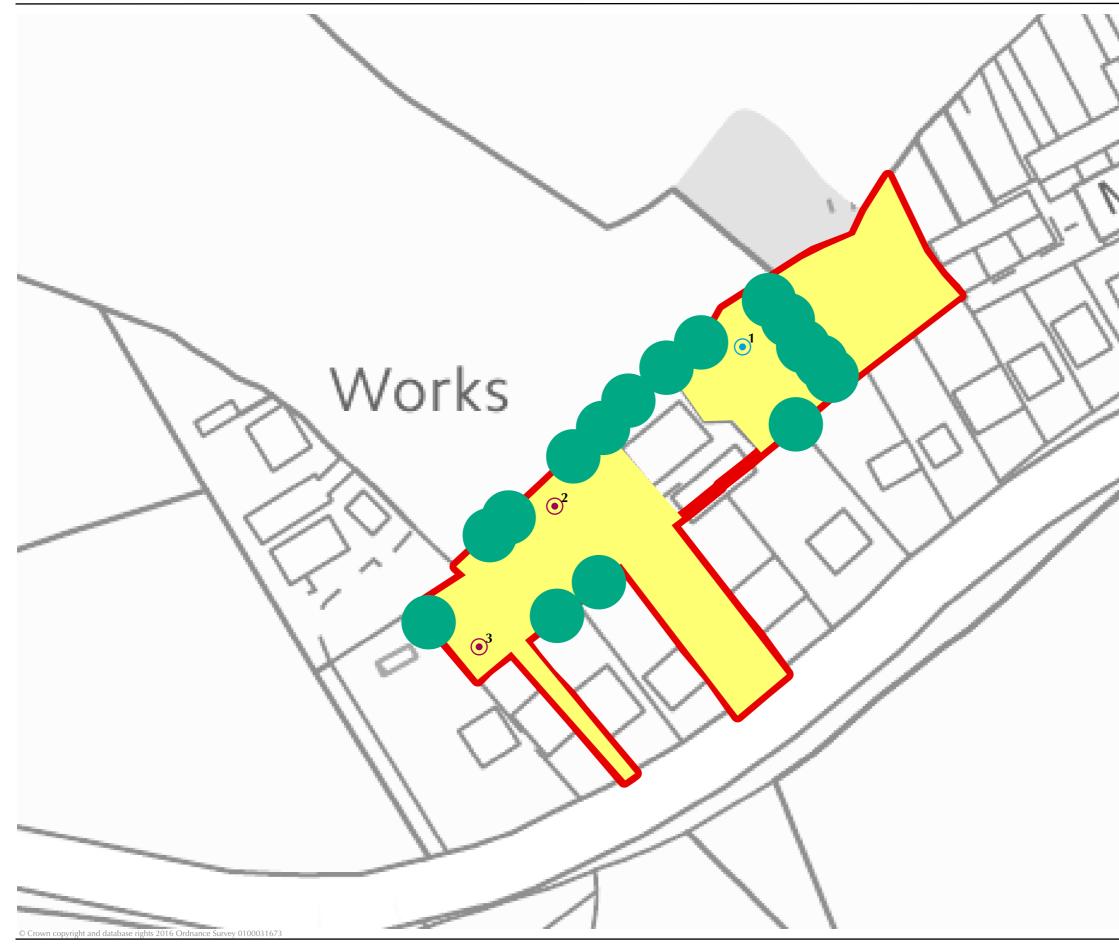
FIGURE 10.7a STONE CROSS: 575/3280 LANDSCAPE AND VISUAL CONTEXT

The landscape and visual context of the Site is shown on **Figure 10.7a**. The key characteristics/features which provide the context to this Site are:

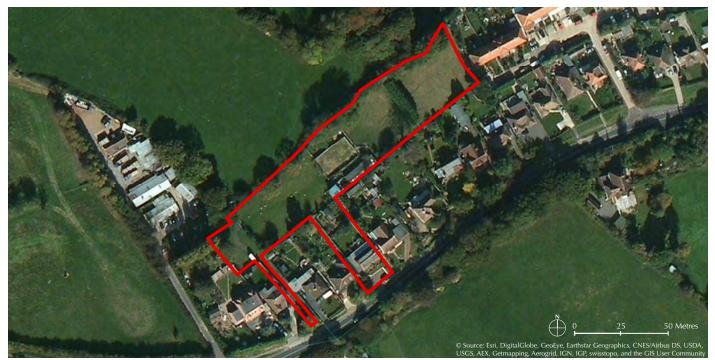
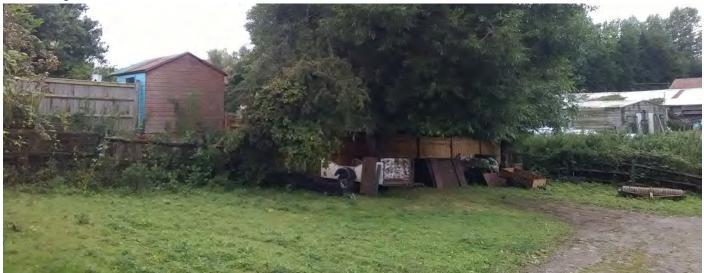
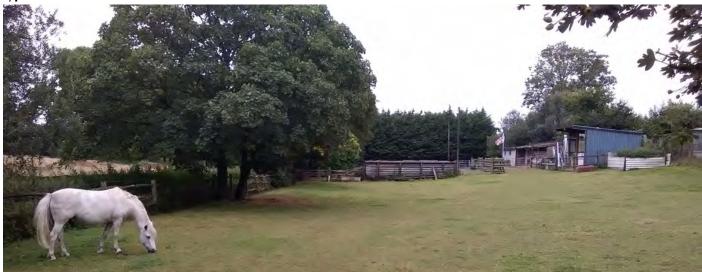
October 2016 11124101_Landscape Figures_20-10-16.indd WEALDEN LOCAL PLAN: LANDSCAPE & ECOLOGICAL ASSESSMENT OF POTENTIAL SITES WEALDEN DISTRICT COUNCIL FIGURE 10.7c STONE CROSS: 575/3280 PHOTOGRAPHS

Aerial Image of Site

Typical View into Site

Typical View out of Site

Typical views of the Site are illustrated by the photographs in **Figure 10.7c**.

The landscape features within the Site are mapped on **Figure 10.7b** and illustrated on **Figure 10.7c**. Located in open countryside, along the rear of existing properties, the Site comprises a series of small paddocks of semi-improved grassland, with fencing, and stable buildings. The Site is influenced by the equestrian land use and it is enclosed by hedgerows and trees.

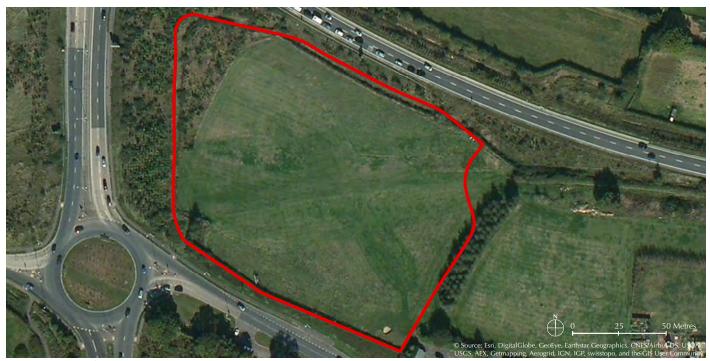
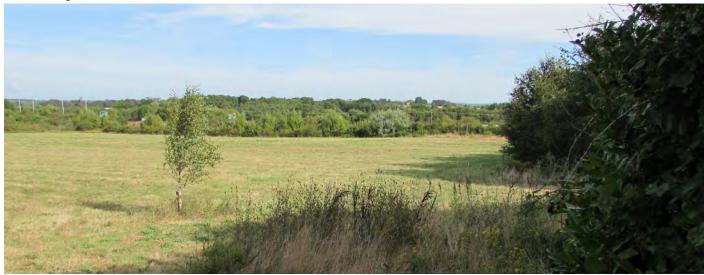
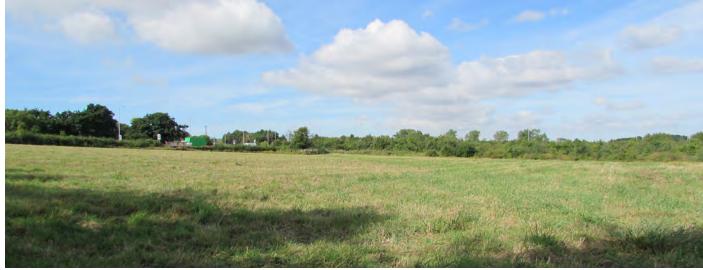
October 2016 11124101_Landscape Figures_20-10-16.indd WEALDEN LOCAL PLAN: LANDSCAPE & ECOLOGICAL ASSESSMENT OF POTENTIAL SITES WEALDEN DISTRICT COUNCIL FIGURE 10.8c STONE CROSS: 677/3280 PHOTOGRAPHS

Aerial Image of Site

Typical View into Site

Typical View out of Site

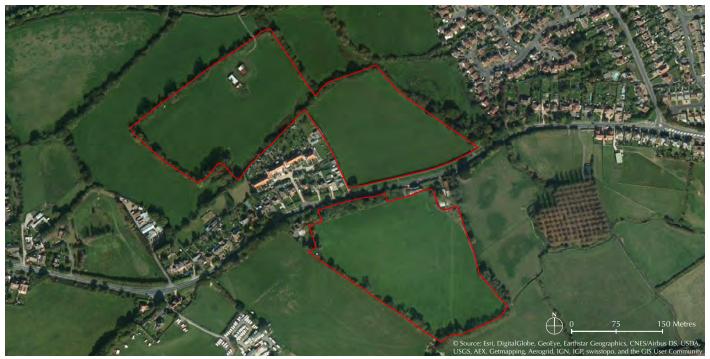
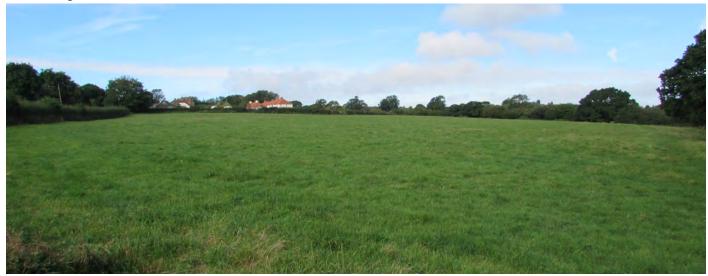
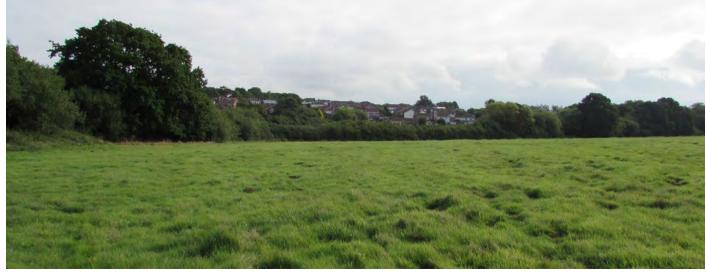
October 2016 11124101_Landscape Figures_20-10-16.indd WEALDEN LOCAL PLAN: LANDSCAPE & ECOLOGICAL ASSESSMENT OF POTENTIAL SITES WEALDEN DISTRICT COUNCIL FIGURE 10.9c STONE CROSS: 712/3280 PHOTOGRAPHS

Aerial Image of Site

Typical View into Site

Typical View out of Site

Key views into the Site are marked on **Figure 10.9a** and typical views are illustrated by the photographs in **Figure 10.9c**.

The landscape features within the Site are mapped on **Figure 10.9b** and illustrated on **Figure 10.9c**. Located on undulating ground the Site generally slopes towards the south. It comprises three fields of semi-improved grassland enclosed by thick hedgerows and trees. The Site is characteristic of its wider landscape and typical of the area around Stone Cross, with its small-scale irregular fields and hedgerows. It has a moderate sense of tranquillity, which is affected by persistent but low-level traffic noise.
